Failure Analysis and Resin Evaluation of IUS SRM-1 92-inch Prototype Motor Case

Prepared by R. W. FILLERS, J. F. WARD, and P. K. GRANT
Materials Sciences Laboratory
The Aerospace Corporation
El Segundo, Calif. 90245

28 September 1979

Interim Report

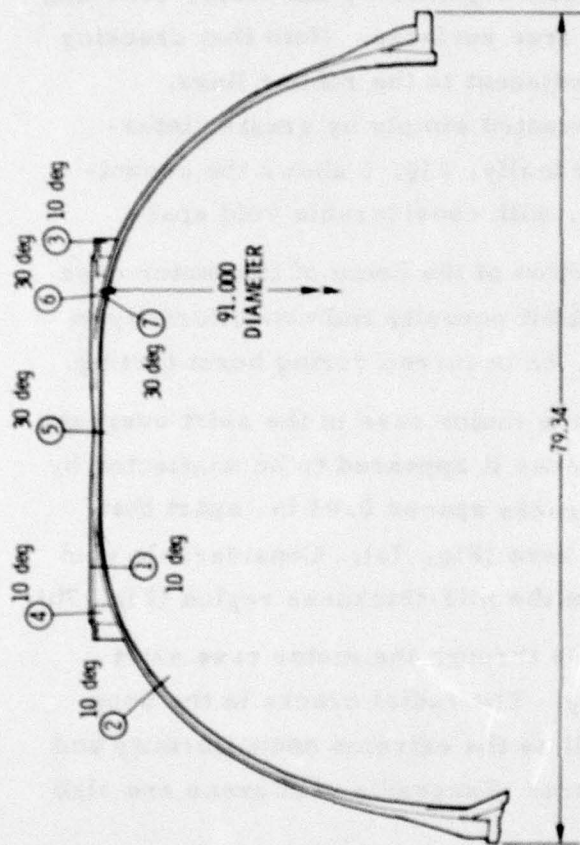
Fig. 4. SRM-1 92-in. Prototype

Figure 4 is a schematic of the SRM-1 92-in. prototype motor case, showing the regions from which the specimens were taken. Both the SEM and optical microscopes were used to analyze these specimens.

Two approaches were used for checking the resin content of the SRM-1 prototype case, an actual fiber count of selected cross sections of the case and Archimedes' principle. Specimens measuring 0.5 in² were taken from the regions noted in Fig. 4. These specimens were weighed both in air and methanol, from which their densities were determined (Table 1). Assuming that no voids are present in the specimen, the weight percent resin is calculated by noting that

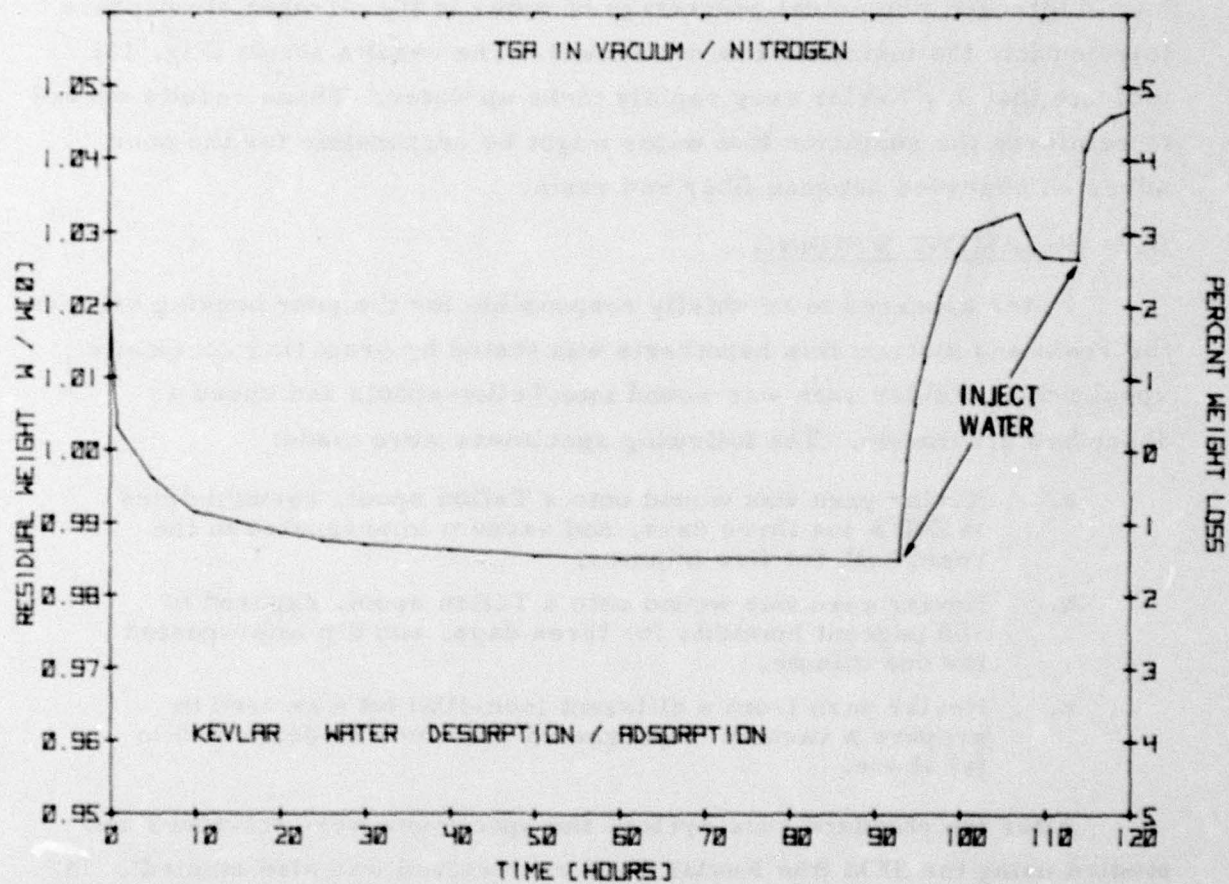
Fig. 13. Water Sorption Characteristics of Kevlar

investigate the rate at which dry Kevlar fiber absorbs or adsorbs water. This instrument utilizes a quartz crystal microbalance to monitor the weight of a specimen, usually as a function of temperature. In this experiment the temperature was held constant, and the weight of Kevlar was monitored with time as the Kevlar was exposed first to vacuum and then to humid nitrogen (the actual percentage of water in the nitrogen atmosphere injected into the instrument is not known). The results shown (Fig. 13) indicate that dry Kevlar very rapidly picks up water. These results served to reinforce the suspicion that water might be responsible for the poor adhesion observed between fiber and resin.

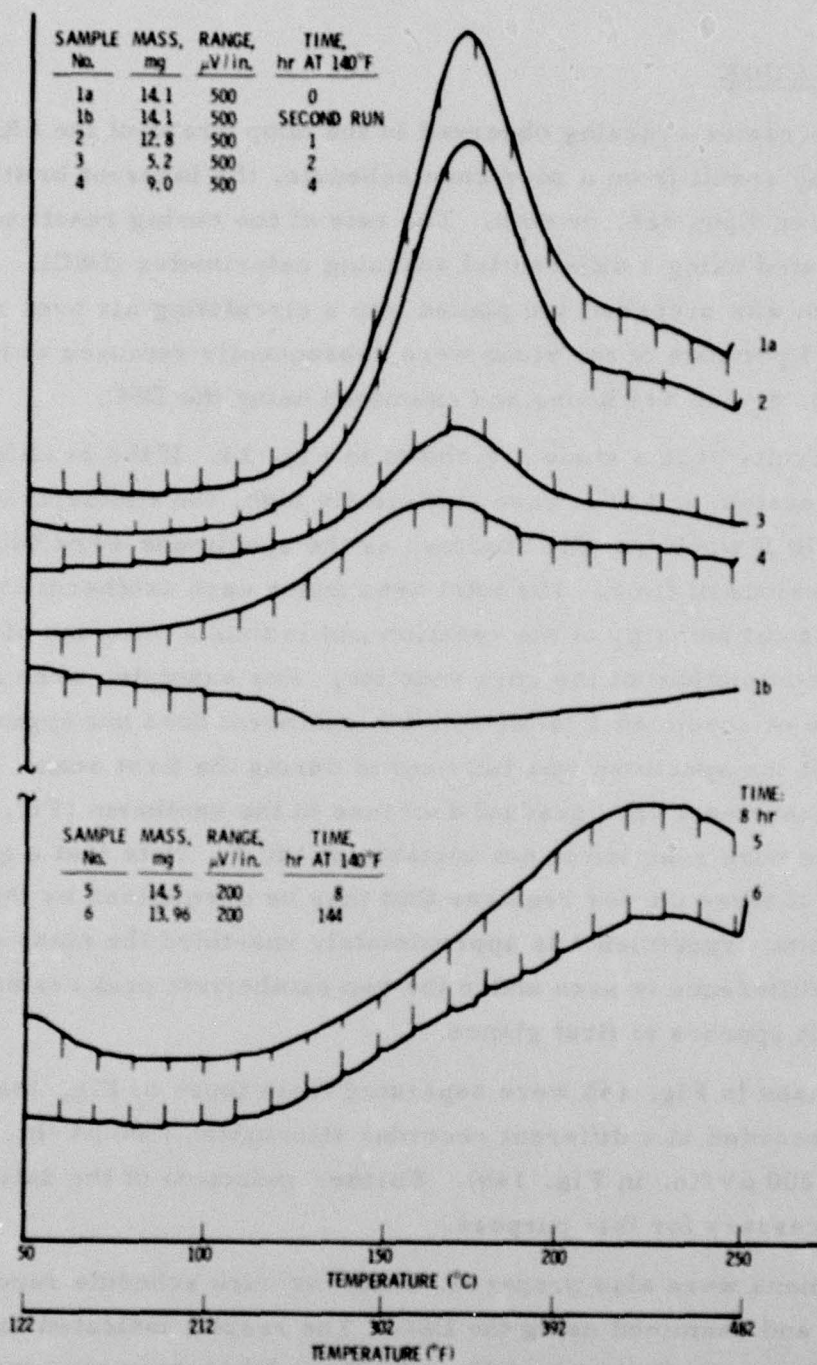
Fig. 14. DSC Studies of MDA-Cured Epon 828

The results of this study are shown in Fig. 14. If the reaction rate of the resin system at 140°F were sufficiently high, the exotherm in the vicinity of 170°F would rapidly diminish as the specimens were held at 140°F for longer periods of time. The total area under each exotherm is proportional to the total enthalpy of the reaction and is thus a measure of the extent (or percent completion) of the cure reaction. For example, when a second scan is made of specimen 1 (scan 1b), the exotherm does not appear, which indicates that the specimen was fully cured during the first scan. The result of measuring a very gradual decrease in the exotherm (Fig. 14) indicates that the cure reaction is not unstable at 140°F. Note that a quantitative comparison of these curves requires that they be normalized by the specimen mass; since specimen 3 is approximately one-third the mass of specimen 1, the total difference in area under the two exothermic peaks is not nearly as great as it appears at first glance.

The scans in Fig. 14b were separated from those of Fig. 14a because they were recorded at a different recorder attenuation (500 μ V/in. in Fig. 14a vs 200 μ V/in. in Fig. 14b). Further reduction of the data was not felt to be necessary for this purpose.

The most alarming result of this study was the fact that the resin system gelled to a weak, brittle solid in three to four days at 70°F. This length of time would ordinarily pose no problem, but the SRM-1 prototype required seven days to wind, and this period will probably not be significantly shortened in the future. The interior of the motor case will thus become quite weak and brittle while the outer portion is still being wound. Additionally, resin flow that normally occurs during the initial phase of the cure cycle does not occur.
